Vermiculite Insulation – Should You Be Concerned?

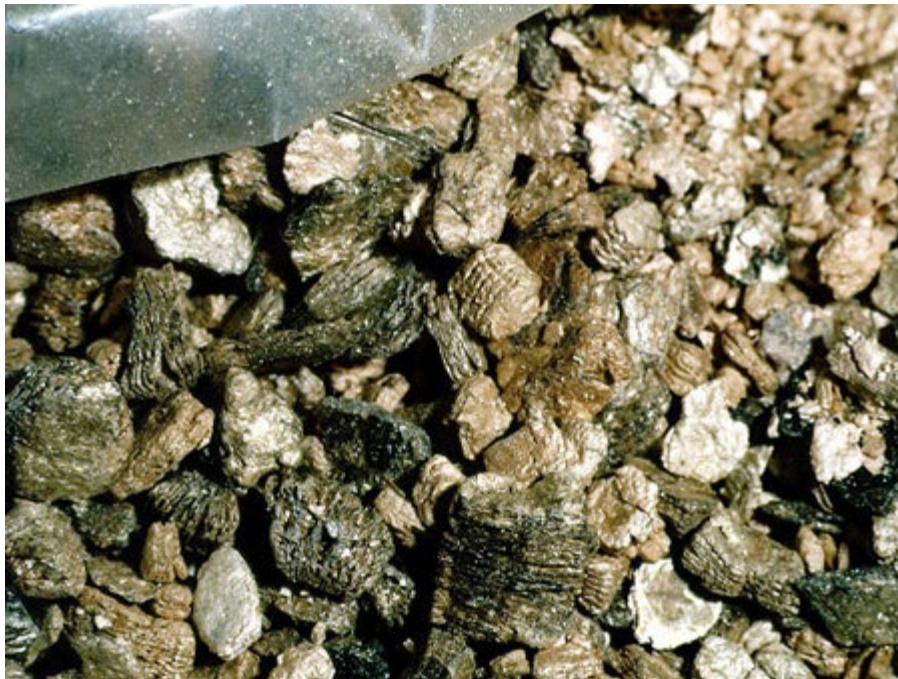
If you have never seen vermiculite insulation in an attic, you may have seen it in potting soil. Vermiculite is a naturally occurring mineral worldwide. When heated rapidly to high temperatures, this crystalline mineral expands into low density, accordion-like, golden brown strands.

In fact, its worm-like shape is what gives vermiculite its name. The worms are broken into rectangular chunks about the size of the eraser on the end of a pencil. In addition to being light, vermiculite chunks are also absorbent and fire retardant. These characteristics make it great as an additive, for example to potting soil. It also makes a good insulating material.
